URGENT – Medical Device Recall

Product: Philips M5071A (adult) and M5072A (infant/child) AED pads
Date: March 2, 2022
Subject: M5071A (adult) and M5072A (infant/child) pads for use with HS1/OnSite/Home AEDs may experience gel separation and reduction of gel surface area

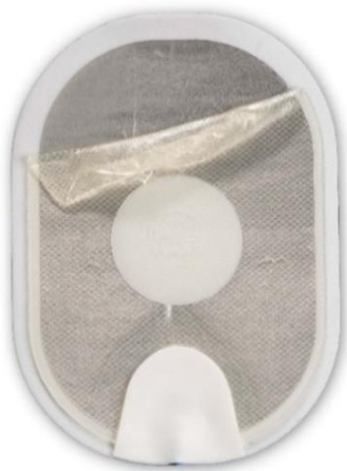
When a pad with separated, folded gel is placed on the patient's bare skin, the HS1/OnSite/Home AED could deliver less effective or ineffective therapy to the patient due to the reduced surface contact area with the skin. See example picture in **Figure 1**.

Figure 1: Separated gel that has folded onto itself when peeled.

Action:
Apply pads to the patient.
Do not hesitate.

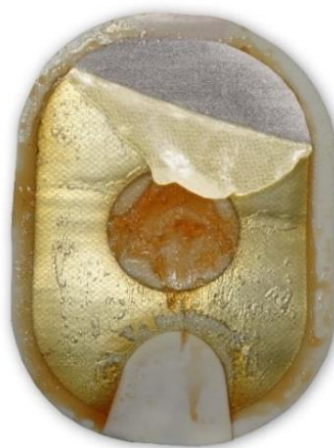
Separated, folded gel may also have a discolored and/or melted appearance. While the gel may also have a discolored and/or melted appearance, the appearance does not have any impact on the delivery of therapy; however, there may be a delay in therapy if the user hesitates to apply the pad due to its appearance, and the AED may deliver less effective or ineffective therapy to the patient due to the reduced contact area with the skin. See example picture in **Figure 2**.

Figure 2: Separated, folded gel may also have a discolored and/or melted appearance.

Action:
Apply pads to the patient.
Do not hesitate.

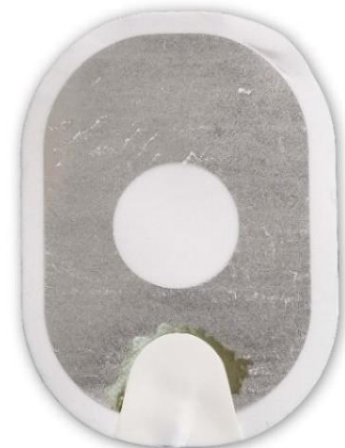
It is also possible that the gel could separate almost completely from the foam/tin backing when peeled, (see **Figure 3**.) Due to a small amount of gel surface contact area with the skin, electrical arcing could occur when a shock is delivered leading to burns to the patient's skin, or the AED could be unable to deliver any shock through the pads. A delay in therapy will result while the user installs a replacement pads cartridge (if available) or performs CPR while waiting for Emergency Medical Services Personnel to arrive. For comparison, **Figure 4** shows a normal pad. No matter the state of the pad, follow the voice prompts because the AED will step you through the necessary actions.

Figure 3: Gel almost completely separated from backing.

Action:
Replace pads cartridge if a spare is available. If no spare is available, perform CPR until help arrives.

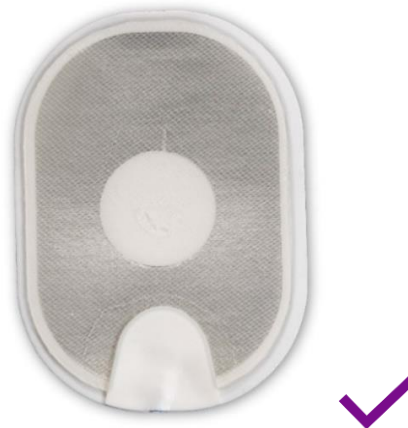
Figure 4: Normal pad.

Action:
Apply pads to the patient according to the Instructions for Use/Owner's Manual.
